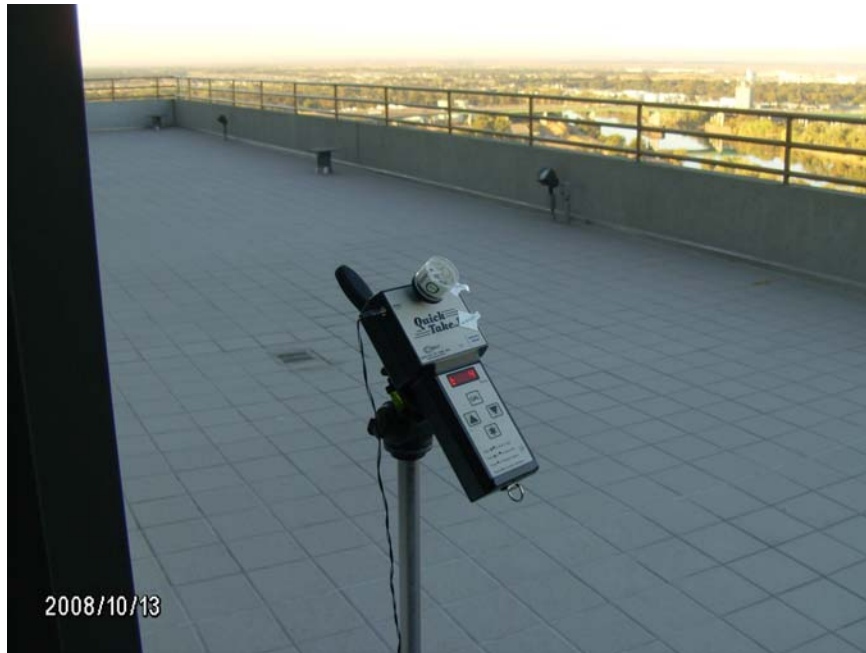
- 1) Image of ambient air sampling location at 23<sup>rd</sup> Floor western balcony of BOE building (Subject Building) located at 450 N Street, Sacramento.

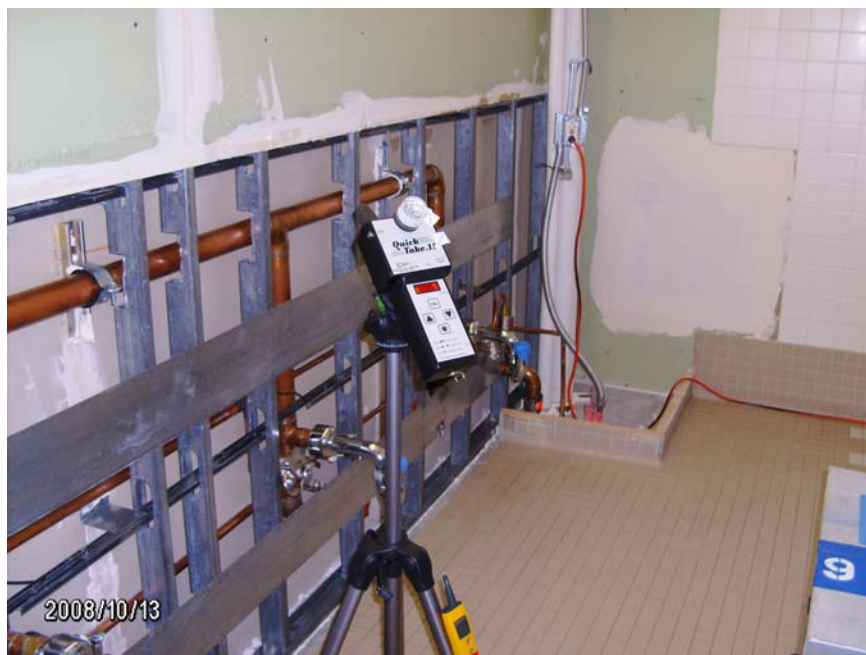
- 2) Image of air sampling equipment located within interior of Men's Restroom containment at time of assessment. Note sheetrock removal at area formerly containing sink cabinets.

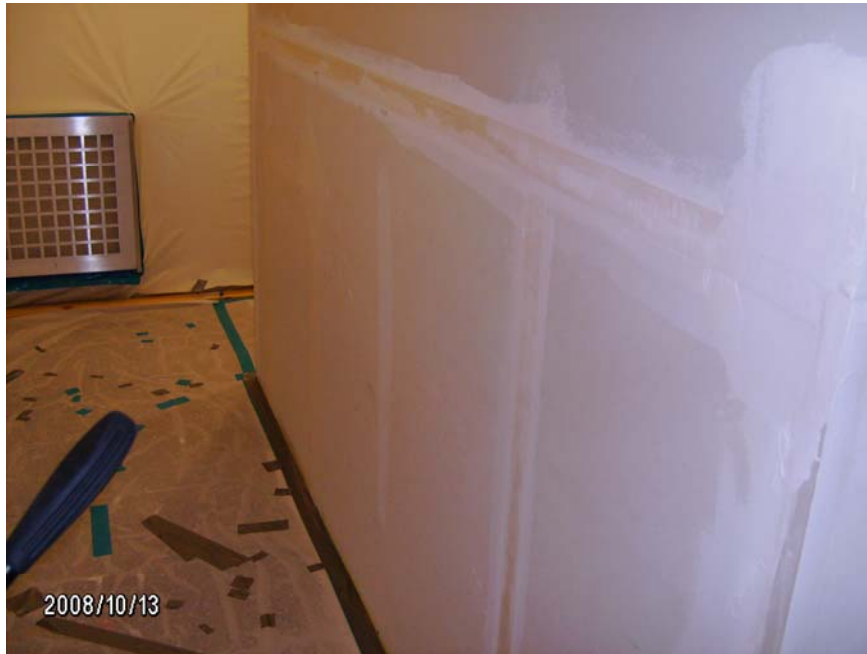
- 3) Image of reconstructed wall within interior of containment erected at center north hallway fountain chase location area at time of assessment.

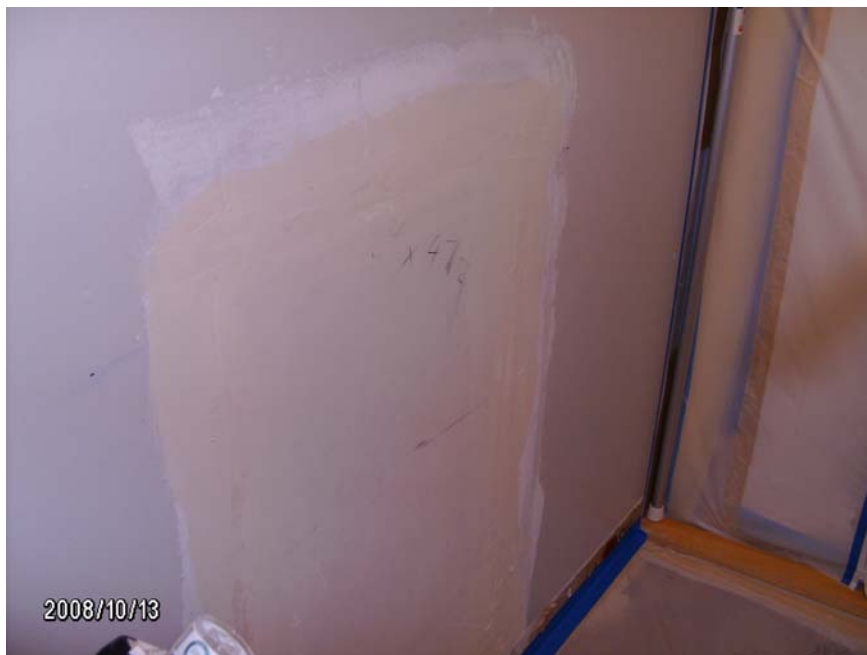
- 4) Image of reconstructed wallboard material within southeast hallway containment structures at time of assessment.

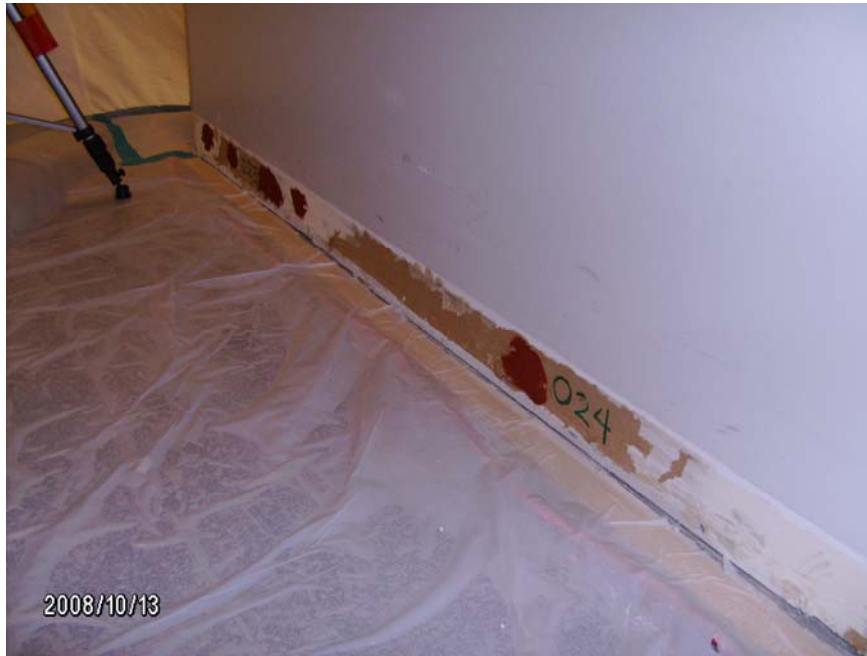
- 5) Image of baseboard removal and LCD sampling locations/ID within center containment of north hallway area.

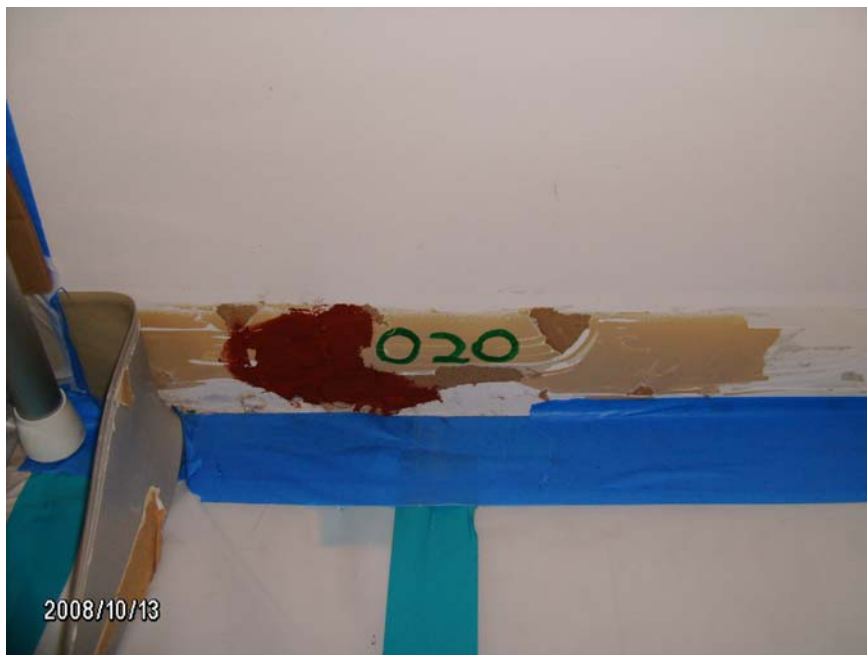
- 6) Close up image of completed LCD sampling/inspection area and repair within mail center containment barrier system at time of assessment.

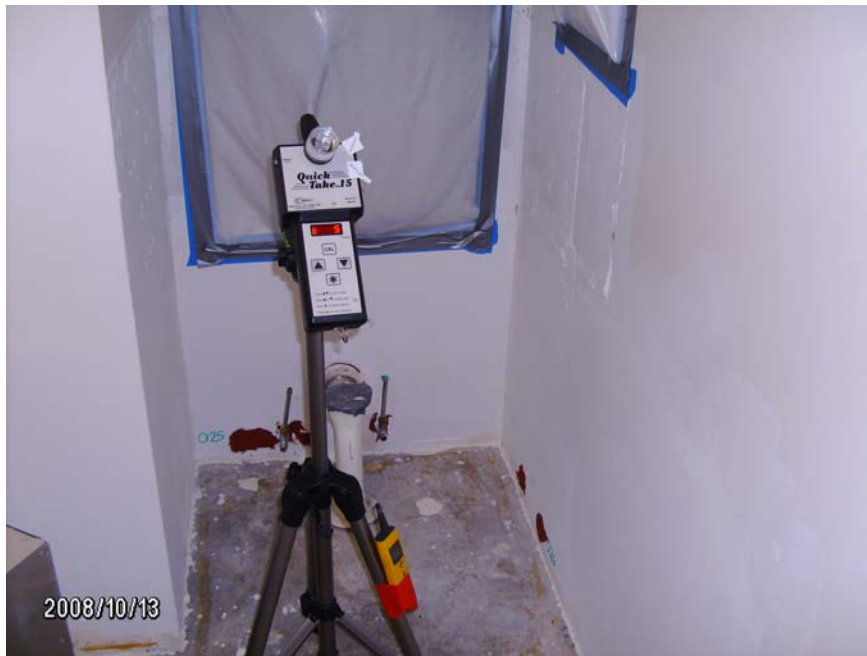
- 7) Image of air sampling equipment and repaired LCD inspection holes located within Janitor's closet room on south side of building.

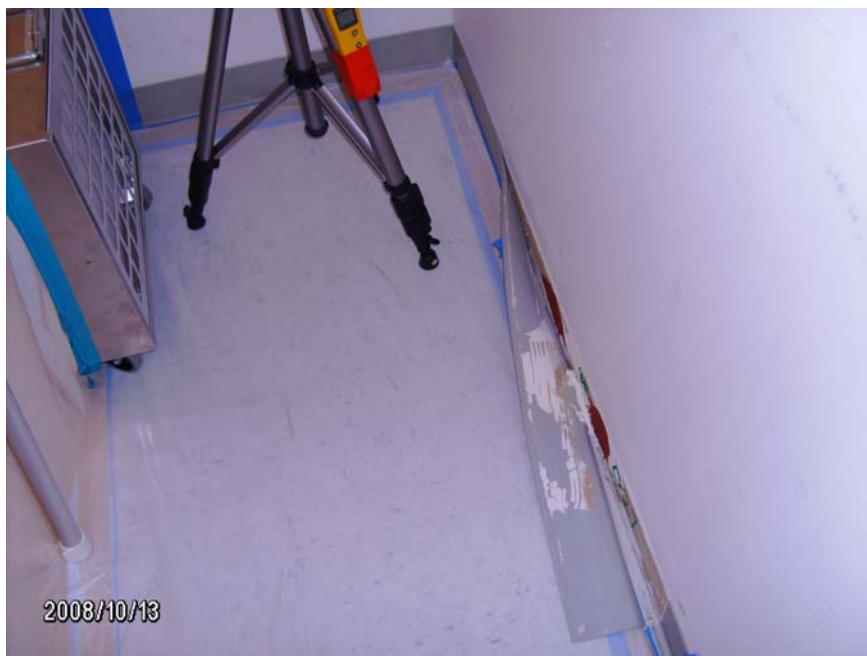
- 8) Image of air sampling equipment and repaired LCD inspection holes located within storage room on south west side of building.

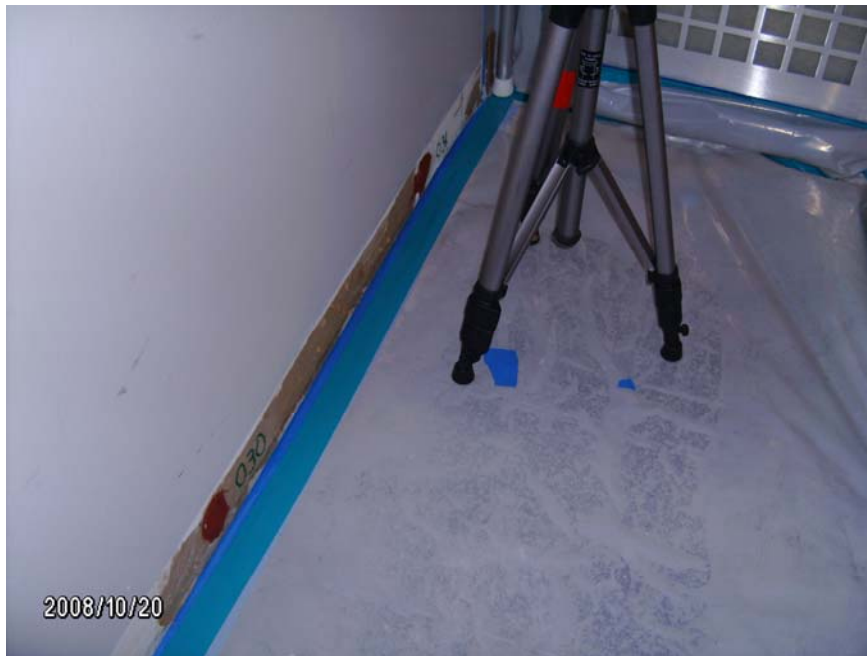
- 9) Image of air sampling equipment and repaired LCD inspection areas within LCD-C-11 containment at time of assessment.

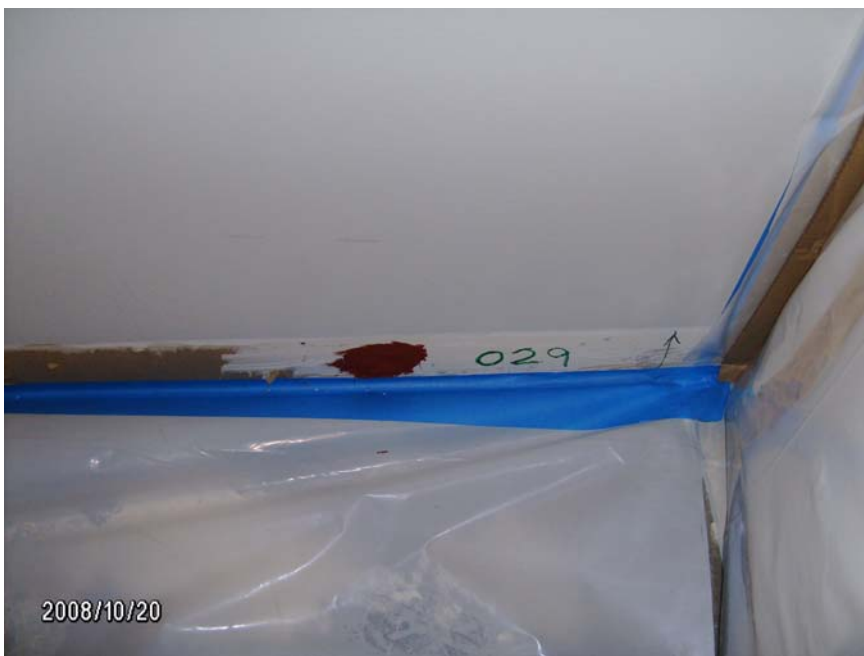
- 10) Image of air sampling equipment and repaired LCD inspection areas within LCD-C-6 containment at time of assessment.

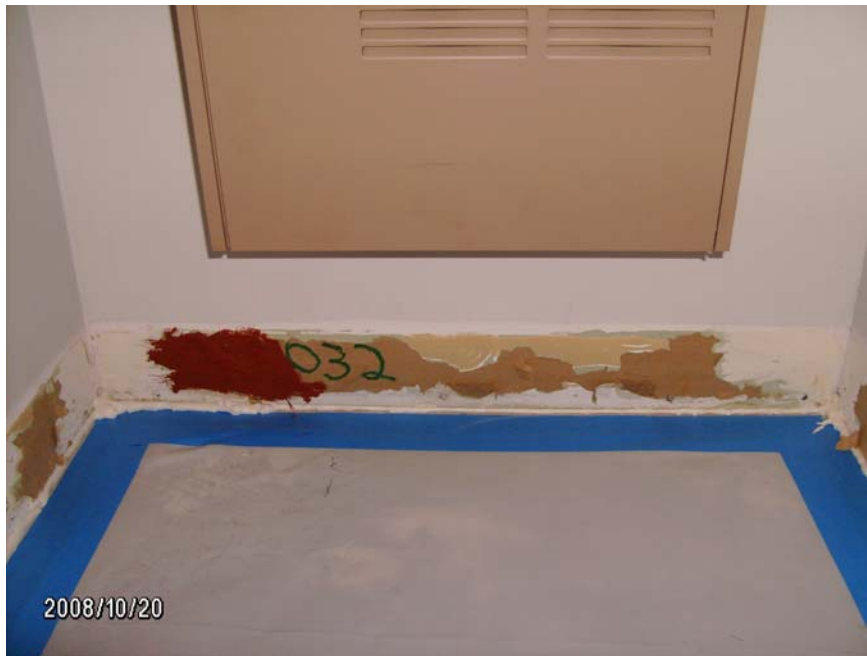
11) Image of repaired LCD inspection areas within LCD-C-7 containment at time of assessment.

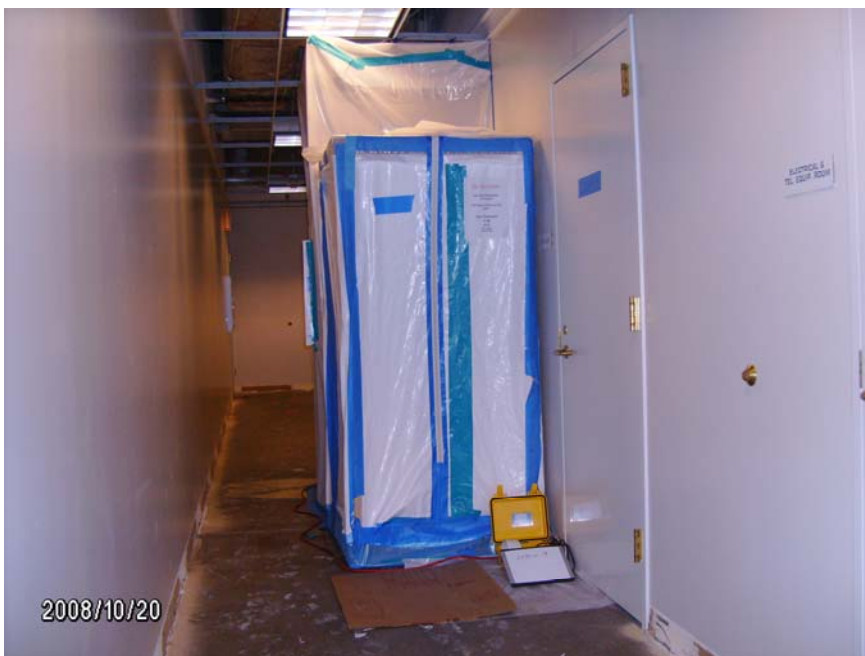
12) Image of hallway containment entrance and structures of LCD-C-7 at time of assessment.

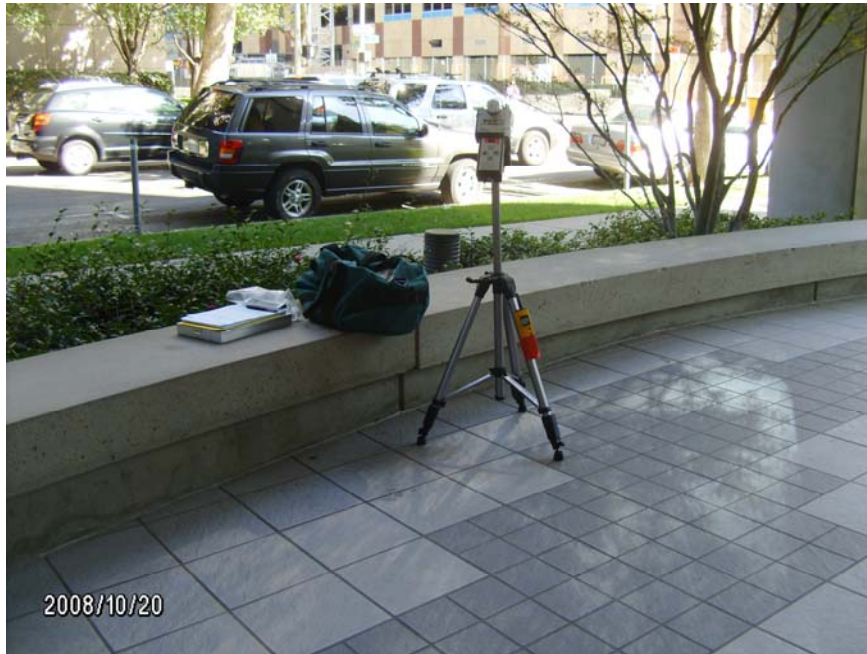
13) Image of ambient air sampling location at main entrance of BOE building performed at conclusion of interior clearance inspection sampling .
